Fort Dupont National Capital Parks | East

Cultural Landscapes Inventory National Park Service

Urban Heritage Project | PennPraxis University of Pennsylvania August 2013 Prepared by the Urban Heritage Project / PennPraxis Graduate Program in Historic Preservation Stuart Weitzman School of Design University of Pennsylvania

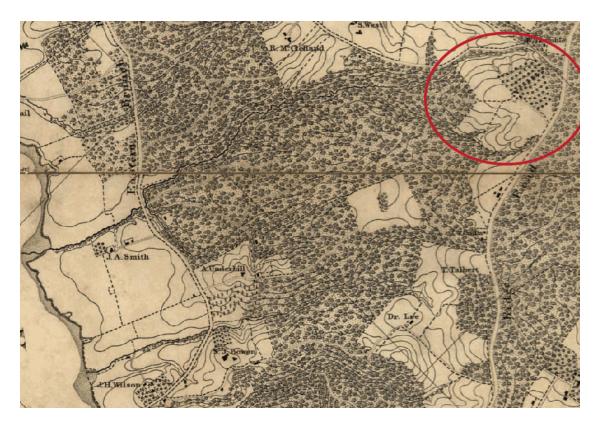
1861: Boschke map of the District of Columbia, with future hilltop site of Fort Dupont highlighted. (Library of Congress, Geography and Map Division)

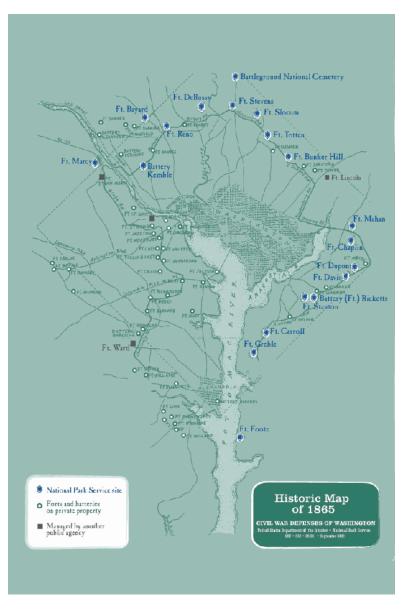
Modified 1865 map of the Defenses of Washington, distinguished by their current ownership and management status. (National Park Service)

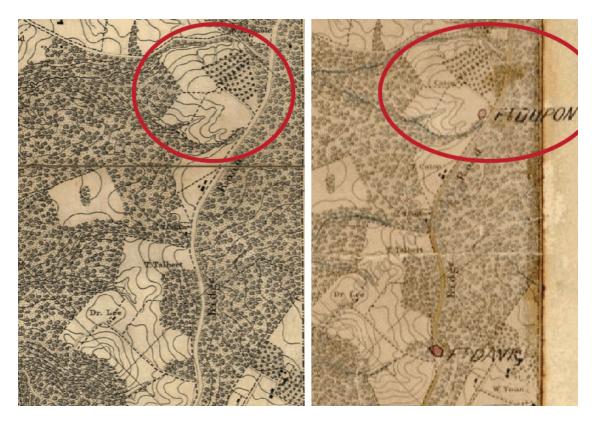
Comparison of the 1861 Boschke map (left) with the 1861 Lines of Defense map (right), developed by Major General John G. Barnar. (Boschke LoC; Lines of Defense, Historic Map Works Rare Historic Maps Collection)

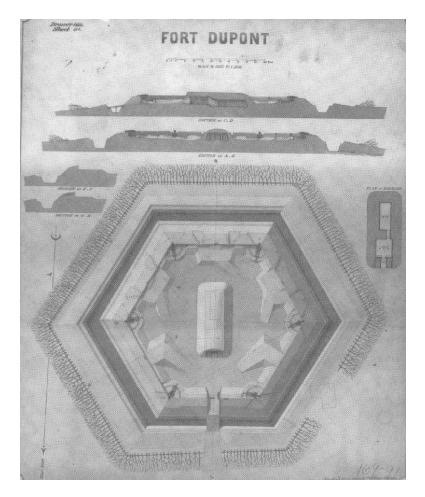
Engineer drawing of Fort Dupont (National Archives, as printed in Mr. Lincoln's Forts)

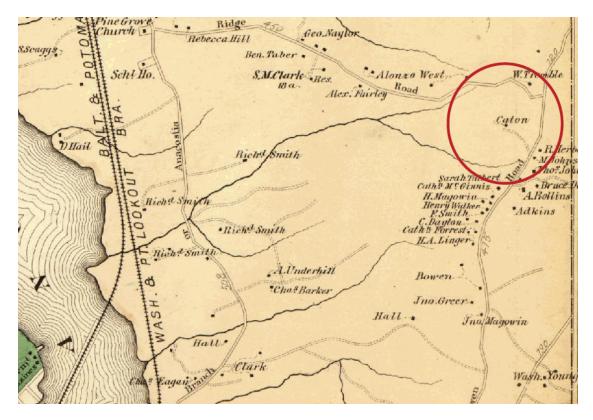
1879 G. M. Hopkins map of the Caton property, showing structure on hilltop (accessible by private drive from Bowen Road). (Library of Congress, Geography and Map Division)

At the time that the McMillan Plan was introduced, the site of Fort Dupont belonged to a Sophia H. Brown. It was still edged by Ridge Road (on its north side) and Bowen Road (to the east). A driveway from Bowen Road still cut a path west through the site (as it had in the 1888 map, and possibly in the 1878/1879 G.M. Hopkins maps), diverting around a house located a few hundred feet to the south of the earthworks. The footprint of this house in the 1903 Baist map echoes the footprint traced on the 1888 United States Coast and Geodetic Survey's Topographic Map of Washington and the Vicinity, which was surveyed when the Catons still owned the property. This suggests that the house that survived into the twentieth century, and was occupied as of 1903 by Sophia Brown, was in fact the Caton house built during the 1870s.

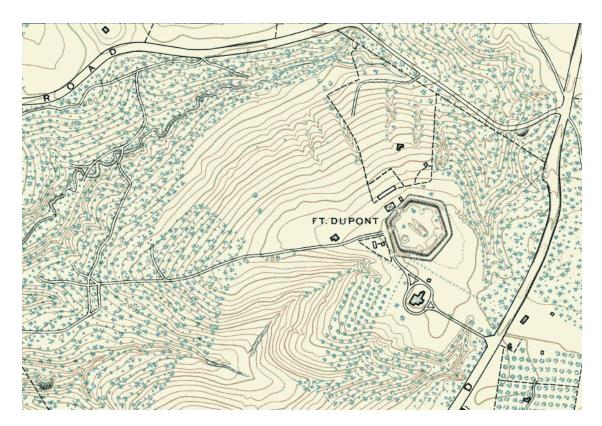
1888 map of the site, indicating presence of Caton/Brown house (at center of driveway) and intact earthworks (north of the house). (NOAA Historical Map and Chart Collection)

On the United States Coast and Geodetic Survey's topographic map from 1888, and its subsequent map from 1892—4, Fort Dupont's earthworks are clearly intact at the summit of the ridge, as are many of the structures and military roads immediately outside the fort (United States Coast and Geodetic Survey 1888; United States Coast and Geodetic Survey 1892-94, as printed in Robinson and Associates 2004: 47). The crest of Fort Dupont's site, including the area within and around the earthworks, remained clear-cut, with the earthworks themselves still fully articulated on the map. A few of the fort's auxiliary structures survived to this point, including several on the northeast side of the earthworks. The fort's access road also remained intact, beginning at Bowen Road (the former Ridge Road, running north-south on the eastern edge of the property) and cutting northwest towards the crest of the hill and the earthworks. Its path is diverted around a large structure south of the earthworks, which was likely the Caton house. A second road began on the west side of the earthworks and descended the hillside (through what is the larger Fort Dupont Park today). The eastern hillside, meanwhile, was reforested by this point, as was a portion of the hillside and valley to the south of the earthworks (and south of the access road from Bowen Road). A plot of agricultural land began at the crest of the hill, to the south of the earthworks and the west of the main house, and covered a portion of the western hillside (United States Coast and Geodetic Survey 1888). Given this integrity of the fort's original fabric by the late nineteenth century, it is little surprise that an 1899 article in the Omaha Daily Bee described both Fort Meigs and Fort Dupont as in "splendid condition." The article further highlighted the "full view of Washington and the valleys of the Potomac" that were available from Dupont's ridge (The Omaha Daily Bee [ODB], July 19, 1899).

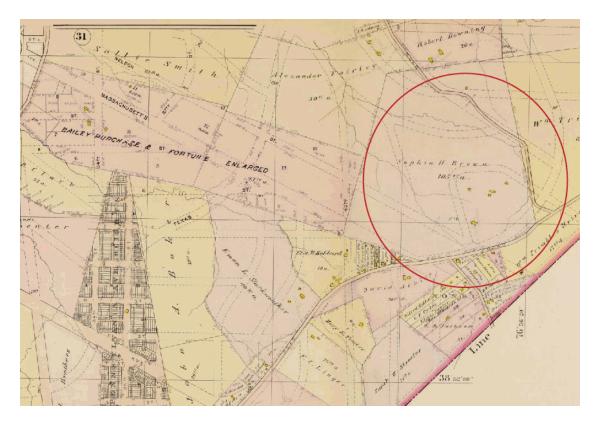
1903 Baist map of the site (then owned by Sophia H. Brown, note the presence of the Caton house & several smaller structures north & east of the house (in the vicinity of the earthworks, which—as natural features—were not mapped by the surveyors). (LoC)

The 1903 and 1907 Baist maps do not make note of the earthworks, since they were surveyed for insurance purposes without any intent to indicate topography or natural features. They do, however, note the continued presence of smaller structures to the north of the house, around or near the earthworks. Although these wood-frame structures are located in the proximity of the earthworks, their locations and footprints do not correspond to those of the structures in the 1888 topographic map, however. They are perhaps, then, new auxiliary structures on the site that were built to replace the temporary Civil War-era buildings (Baist 1903).

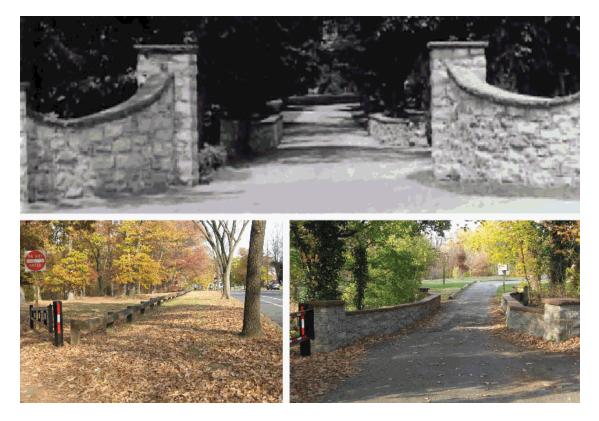
Fort entrance in 1932 (top) & today (bottom). The taller walls from 1932 are no longer extant. The shorter bridge walls (center top; bottom right) were rebuilt in the early 1950s. (Top: Office of Motion Pictures, USDA; Bottom: CLP, 2012)

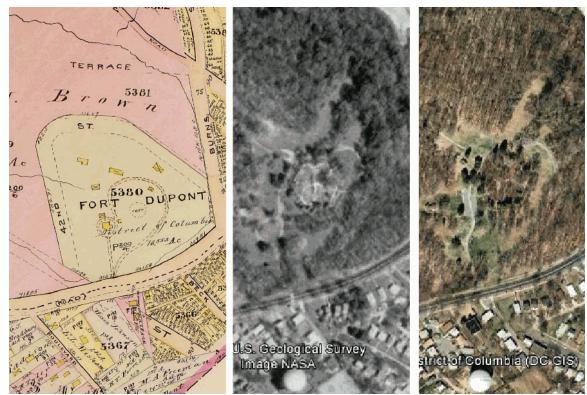
Map and aerial photographs showing the changes in circulation features from 1919 (left) to 1988 (center) and 1999 (right). (LoC; USGS, via Google Earth; District of Columbia GIS, via Google Earth)

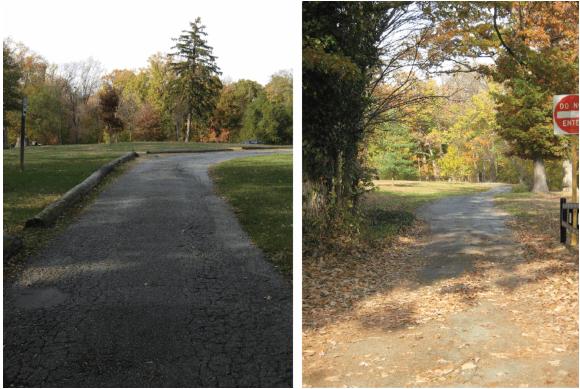
Current conditions of the fort loop driveway, including the entrance (left) and the exit (right). The two meet at the park's Alabama Avenue entrance. (CLP 2012)

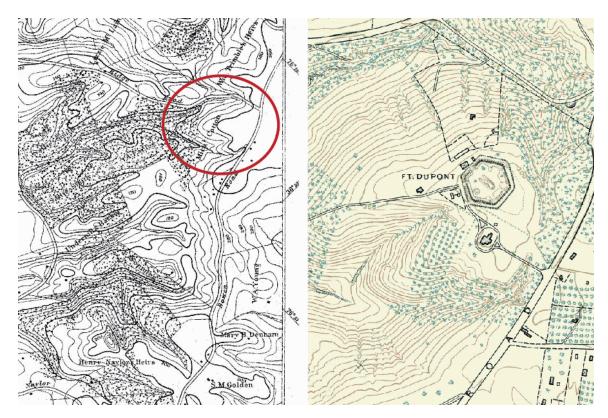
1884 (left) & 1888 (right) maps of Fort Dupont's hilltop show the clearcut vegetation pattern, particularly on the west. (NOAA Historical Map and Chart Collection)

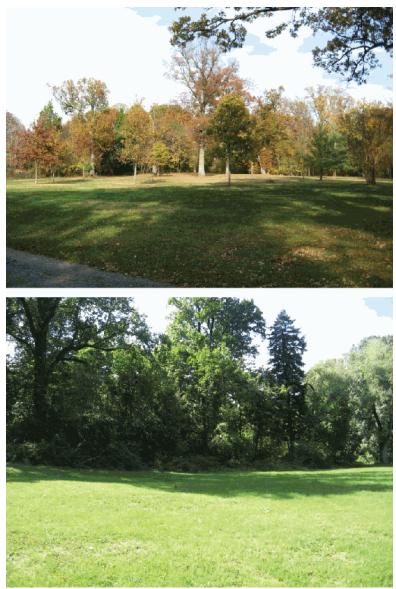
Existing vegetation conditions on the site, including the open grassy area surrounding the earthworks (top) and the dense tree cover and growth covering the earthworks (bottom). (CLP 2012)

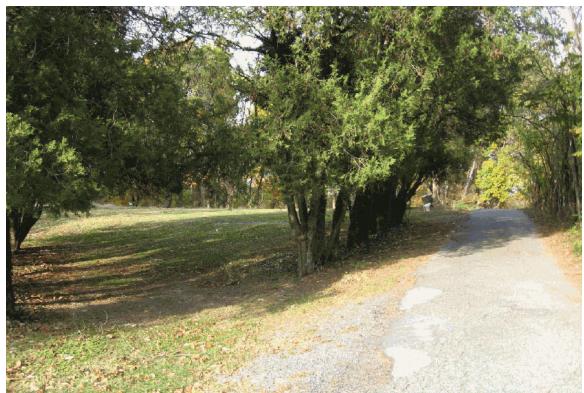
These rows of red cedar trees, located west of the earthworks, reflect the site's temporary twentieth-century use as a tree nursery. They likely edged one of the auxiliary structures on the site. (CLP 2012)

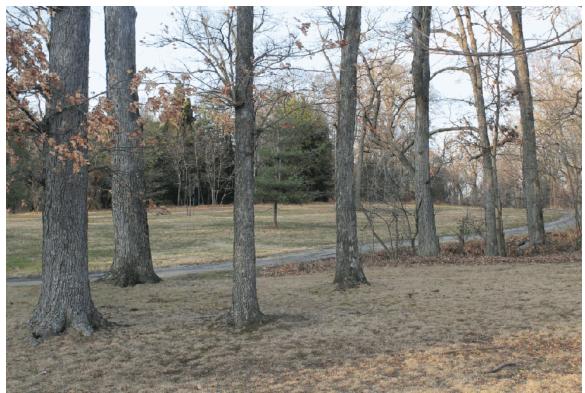
View from east of the earthworks, looking west at the tree plantings (which may date to the 20th century periods of significance, as the site was converted to public parkland), the fort loop driveway, and the earthworks in the background. (CLP 2013)

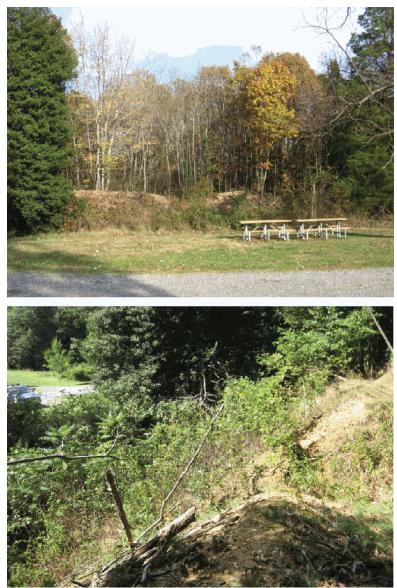
View of the earthworks from the parking area (top) & parapet wall (bottom). Erosion has more of an impact on this side of the fort due to tree removal. (CLP 2012)

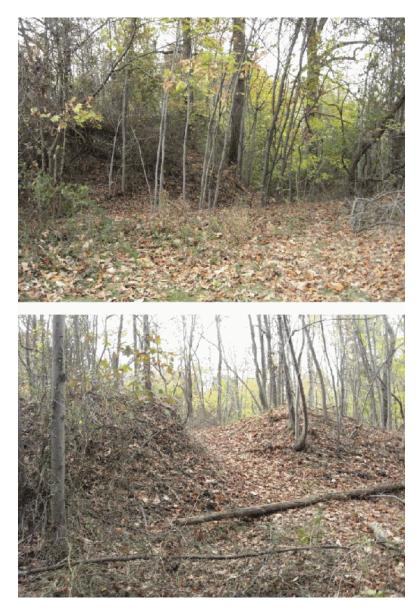
The earthworks remain extant. Features such as the parapet walls & ditches (top) & the collapsed magazine (bottom) are clearly visible, despite the presence of dense undergrowth and mature tree cover. (CLP 2012)

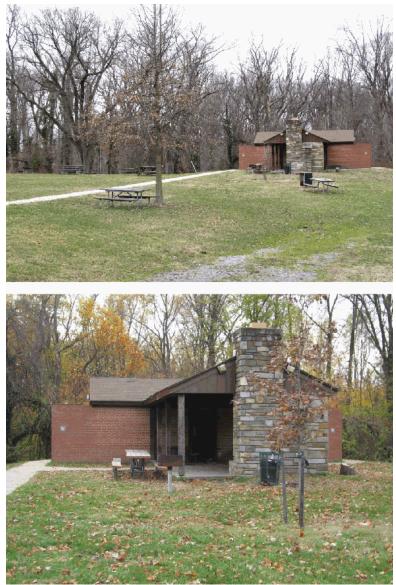
The picnic area (top) and comfort station (bottom). They are both non-contributing, having been built in the 1950s (CLP 2012)

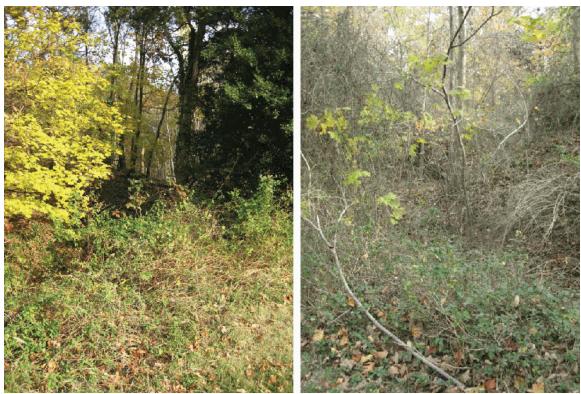
The existing views and vistas from Fort Dupont are obstructed by growth on the earthworks. This disrupts any integrity of views from the fort, which originally looked towards the other forts. (CLP 2012)

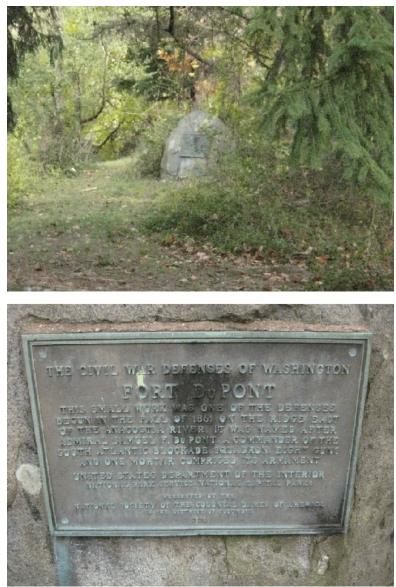
The commemorative boulder and plaque along the western edge of the earthworks were placed at the site in 1955 by the National Society of Colonial Dames. It is a non-contributing feature. (CLP 2012
