Marion Park

National Capital Parks - East

Cultural Landscapes Inventory
National Park Service

Urban Heritage Project | PennPraxis
University of Pennsylvania
June 2020

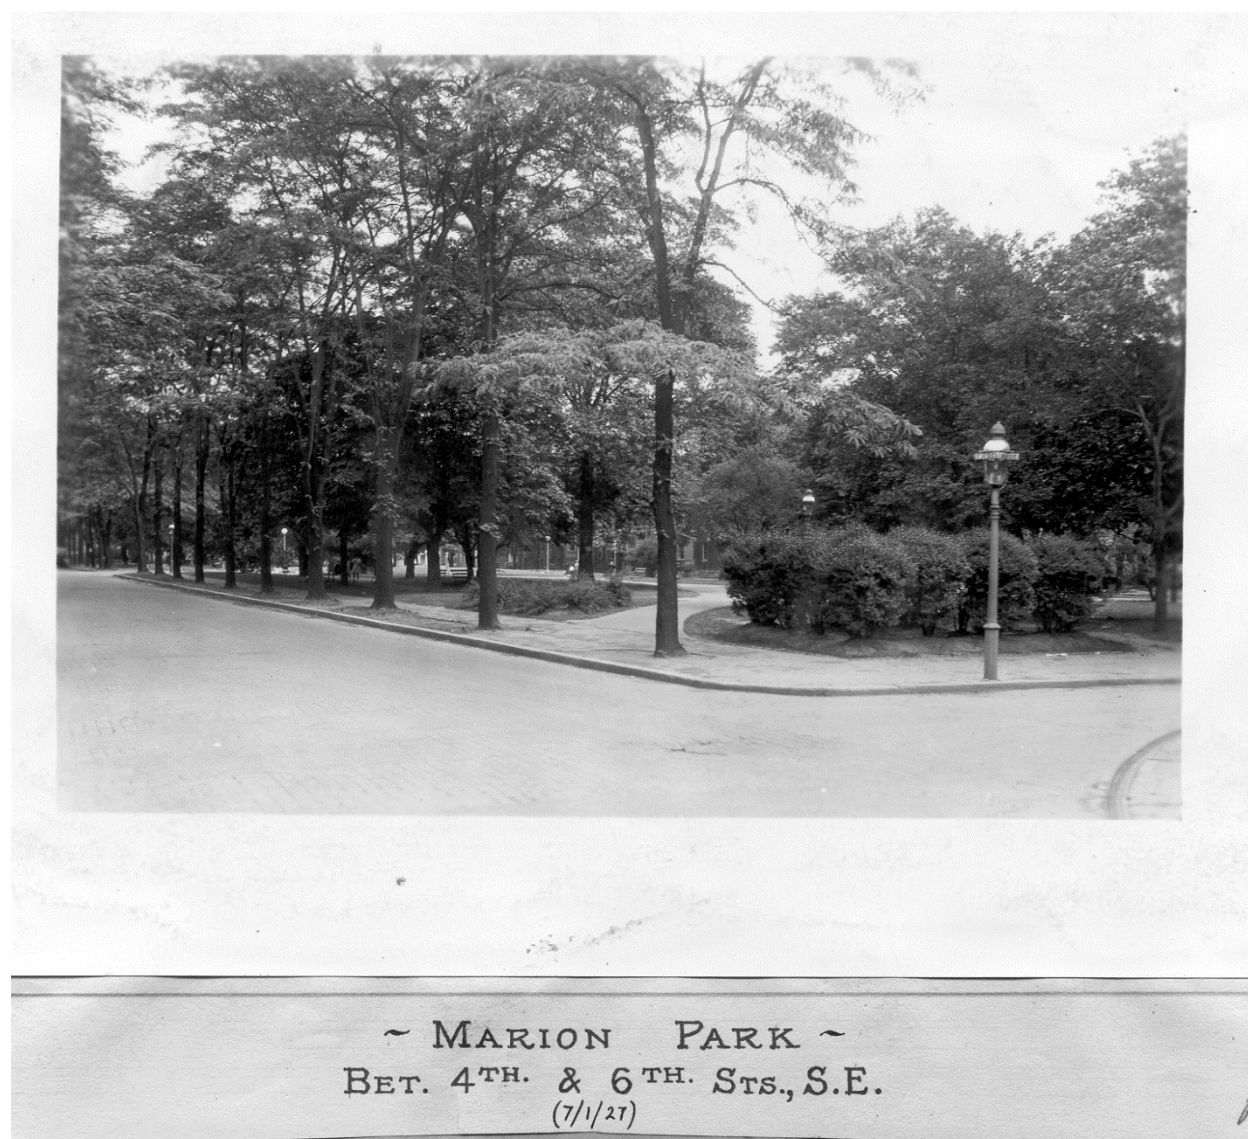
FIGURE 16: Landscape conditions in Marion Park in 1927, as viewed from the southeast (Reservation 18, Reservation Files, National Capital Region, National Park Service)

In 1926, the Office of Public Buildings and Public Parks began a program of documenting and photographing each reservation in Washington's park system. Over three years, the agency surveyed every public park within the city. A photo of Marion Park taken in 1927 shows that by this time, views into and out of the park were greatly affected by the densely planted foliage along the cultural landscape's boundaries. Trees line the edges of the cultural landscape. The central portions of the park consisted of grass lawns, while the edges of the park consisted of dense canopies of mature trees. The curvilinear pathways dating to the original 1885 plan were paved by this time. Large shrubs (of unknown species) at the corners of the park forced users to enter the meandering paths at specific points, without cutting across the park mid-block. Several benches, lampposts, and the fountain are pictured in the background of the photograph, within the Marion Park cultural landscape.

After maturation, densely planted vegetation along the edges of cultural landscape directed internal views within the park along its paths. Views within the park along the east-west walkways became more prominent. These views were framed by vegetation within the cultural landscape (See Figure 16; Reservation 018, Reservation Files, NCA).

According to historic records, few changes were made to the vegetation between the 1905 rehabilitation and the time a photograph was taken of the park in 1927 (See Figure 16). In 1920, seven deciduous shrubs of unknown variety and location were planted to replace damaged and missing ones (1920 OPBG Annual Report). A survey conducted in 1925 by the Office of Public Buildings and Public Parks listed 1,444.27 square feet of flower shrub beds; 1,053.60 square feet of flower beds, and 46,009.56 square feet of lawn (Park Plan 1925, included in HABS-DC 679). No other changes were recorded prior to 1927.

A photograph taken in 1927 shows the maturation of OPBG-era plantings. By this time, shrubs and planting beds created dense screens on the edges of the park near entrances. Closely planted rows of honey locust (*Gleditsia triacanthos*) trees lined the north and south sides of the park. It is unclear what other species of plants are visible in the photograph. In 1928, four unspecified trees were damaged in Marion Park during a storm.

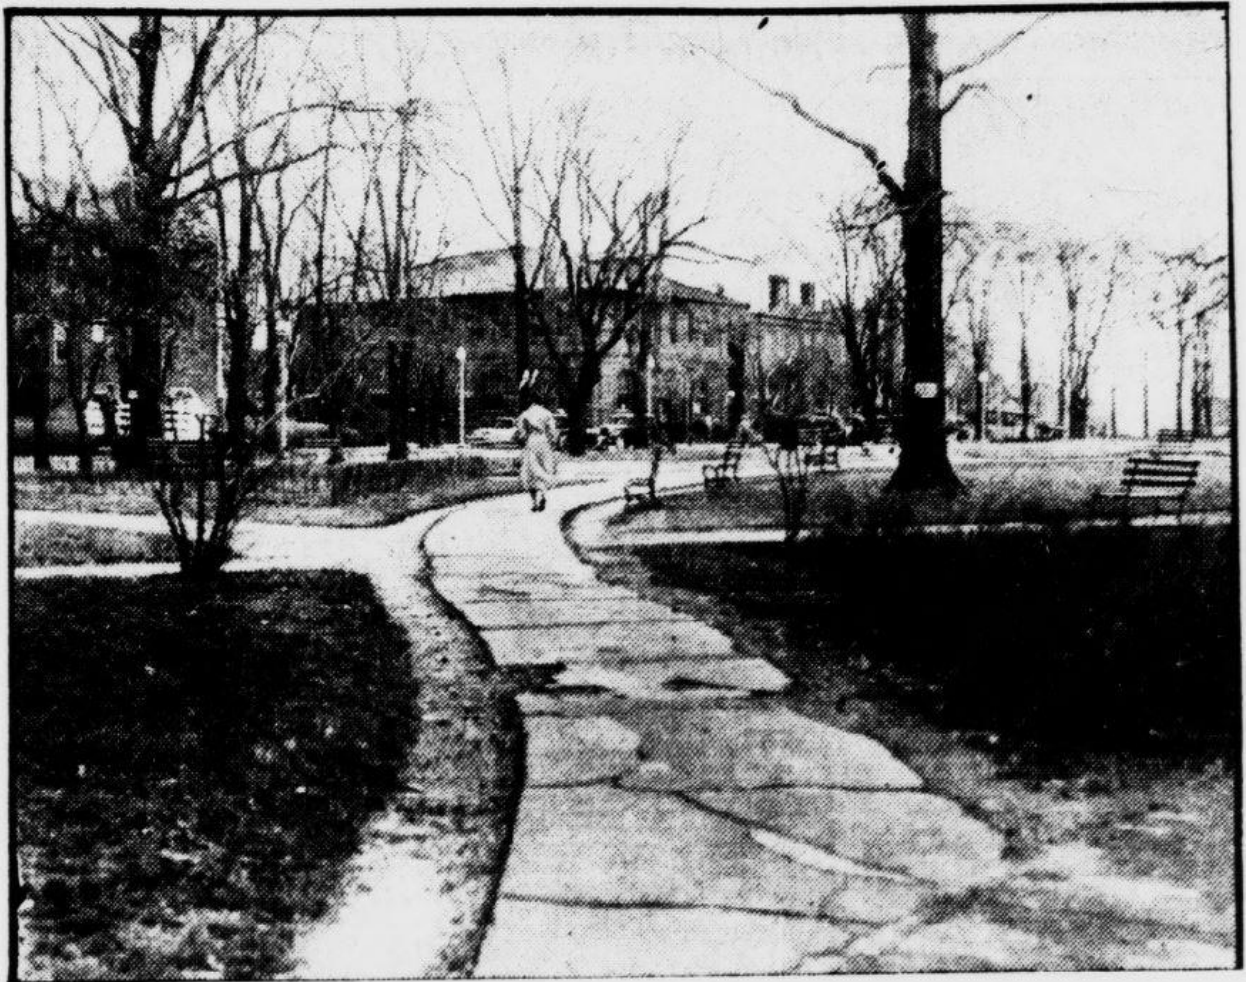
FIGURE 17: By 1935, conditions in Marion Park had greatly deteriorated. The paved walks were cracked and pitted, vegetation had become sparse (even accounting for the fact that this photograph was likely taken in early spring) and grassy areas patchy. (*Evening Star*, May 26, 1935: A3)

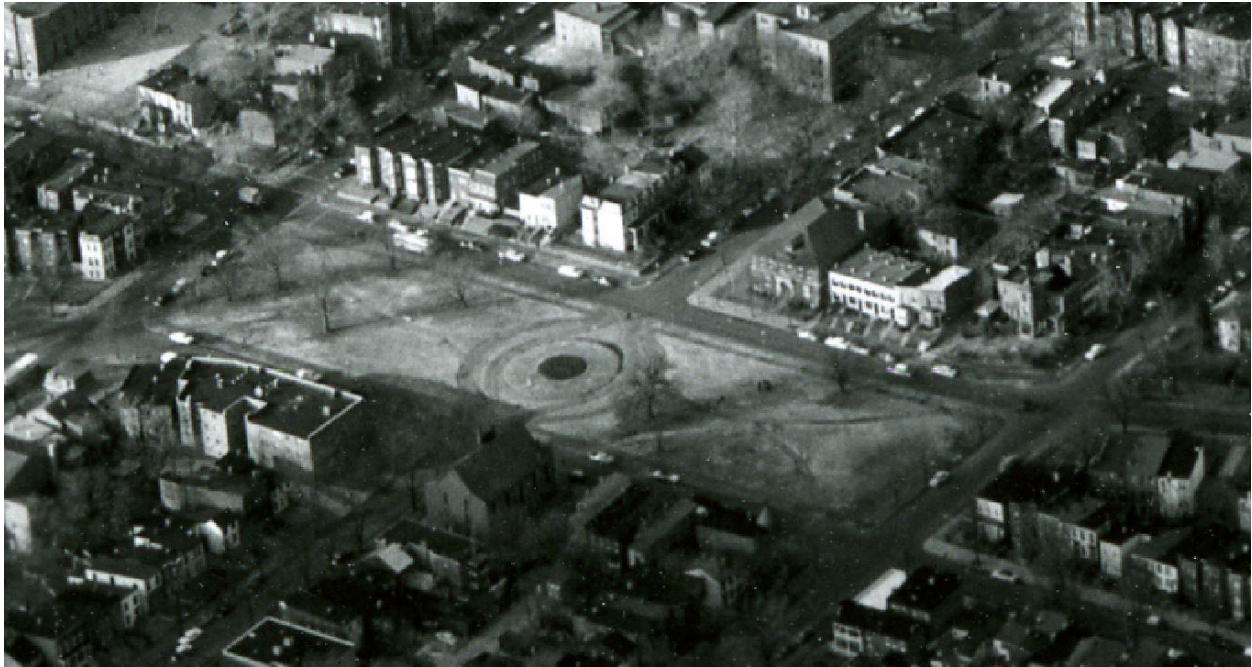
FIGURE 20: Post-WWII conditions of Marion Park in 1955. Note the loss of nearly all the trees and shrubs along the edges of the park and the park's openness as a result of the changes in vegetation. (Excerpt from AE 381, Whetzel Aerial Photograph Collection, Kiplinger Library)

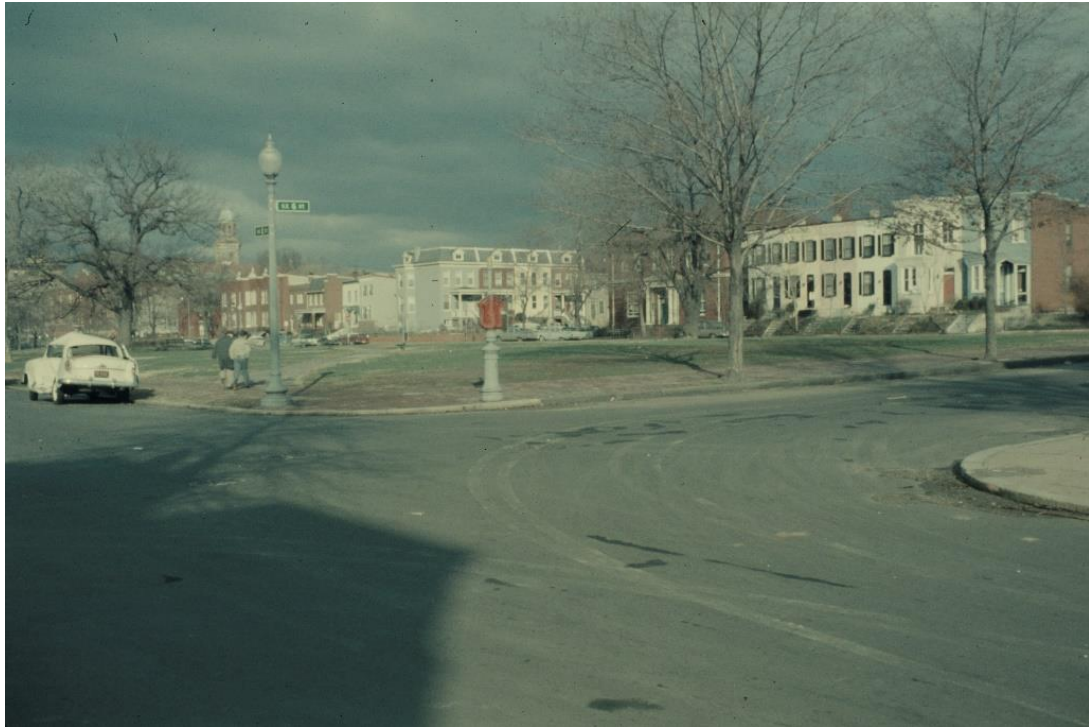
FIGURE 23: Few trees or small-scale features existed at Marion Park by the time this photo was taken in 1961. View across Marion Park to the north side of the 500 block of E Street SE. (PR 0425A Emil A. Press Collection, Kiplinger Library)

By 1961, conditions in Marion Park had greatly deteriorated amid numerous failed redesigns. The cultural landscape retained its spatial organization, land use, and views and vistas from previous periods. However, few small-scale features and little vegetation remained in Marion Park by 1961, as many of these features had been actively removed. A contemporary plan noted ten trees remaining in the western half of Marion Park, and six in the eastern half of the park. A photograph from the same year shows several large trees on the edges of what was by then a vastly open Marion Park. These trees are likely two sugar maples (*Acer saccharum*) in the foreground, a big-leaf linden (*Tilia platyphyllos*) in the center back, and a large pin oak (*Quercus palustris*) at left. Pictured are traces of the paved curvilinear walkway at the corner of E Street SE and 6th Street SE, as well as several benches.

walkways were paved with cement prior to this time, but it can be assumed these were the same walkways covered in asphalt in 1902. Photos of the walks in this article show that only the major east-west paths had been paved, while others remained dirt and gravel (See Figure 17). A preliminary development plan of the park from 1957 shows extant brick walks along the north and south edges of the park and along the circular drive (these likely dated to the OPBG-era), but does not include other paths within the park (“Preliminary Development Plan,” 1957). This could be either an omission, or more likely, an indication that the walks within the park had so greatly deteriorated that little remained to indicate their locations. A 1961 photo of Marion Park supports this conclusion (PR 0425A, 1961). This photo shows few circulation features within the cultural landscape and only minimal traces of the OPBG-era paths (See Figure 23).

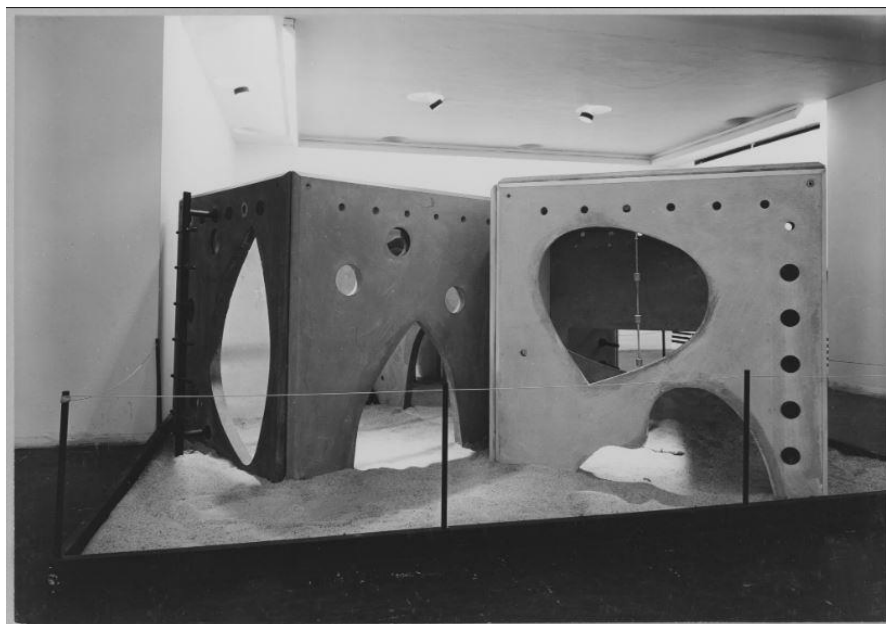
FIGURE 31: Artist Virginia Dortch Dorazio's winning design "Fantastic Village" was exhibited in the Museum of Modern Art in 1954. Variations of Dorazio's design were sold by Play Structures, one of which was later installed in Marion Park in 1964. (Soichi Sunami, The Museum of Modern Art Archives, New York, IN562.3)

The winning designs of the MoMA contest were exhibited in the museum in 1953. The first-place prize went to artist Virginia Dortch Dorazio for her design "Fantastic Village," which featured modular concrete walls with various holes that could be combined infinitely to meet the needs of any playground site. Winning designs from the MoMA contest were then sold through company catalogues and began appearing in parks across the country shortly after the competition.

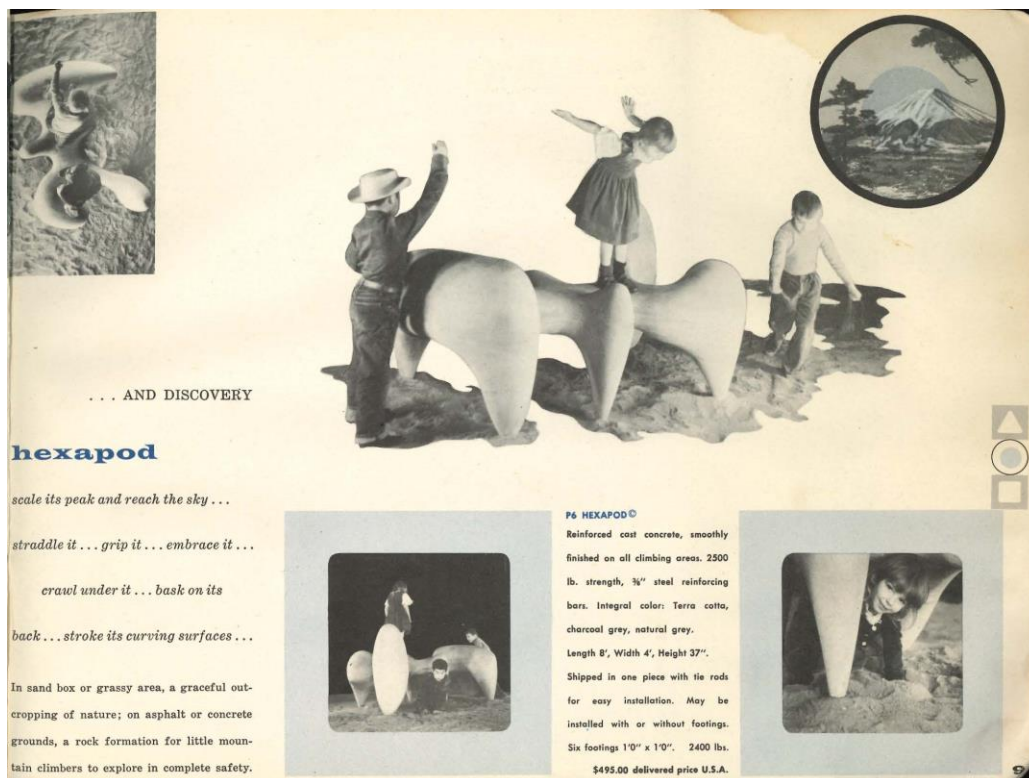
FIGURE 32: Creative Playthings and Play Sculptures commissioned Robert Winston to create the Hexapod, a concrete and steel play sculpture that was poured in places in two parts. One such hexapod was installed in Marion Park in 1964 (*Play Sculptures: A New World of Play*, 1958).

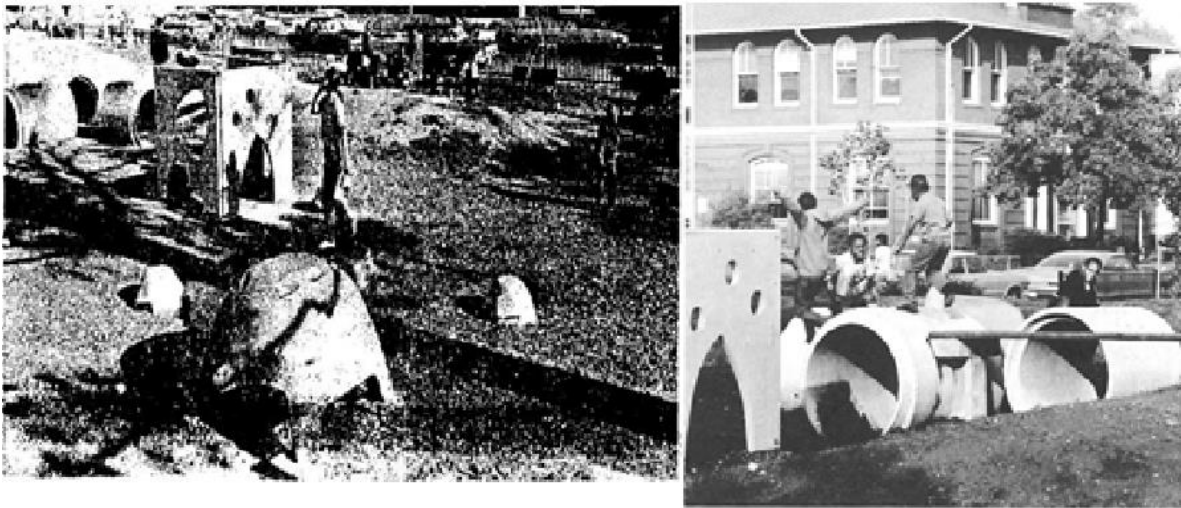
By Elsworth Davis—The Washington Post
Marion Park: Its grassy mounds are now solid dirt or, when it rains, mud. PLAYGROUNDS. CAPITOL EAST is badly in need of more play-ground space, and four large neighborhood centers, and 35 small centers, most of them playgrounds, are needed.

FIGURE 34: A 1967 and 1968 photograph of the Marion Park playground, respectively. (left) Conditions of Marion Park’s playground berms had become muddied due to extensive use. (right) The 1968 photo on the left was used in the D.C. Comprehensive plan of that year as an unspecified example of a playground in a section of the plan that called for the expansion of playgrounds. (*The Proposed Comprehensive Plan for the National Capitol*, 1967: 143; *Washington Post, Times Herald*, Apr. 30, 1967: B1)

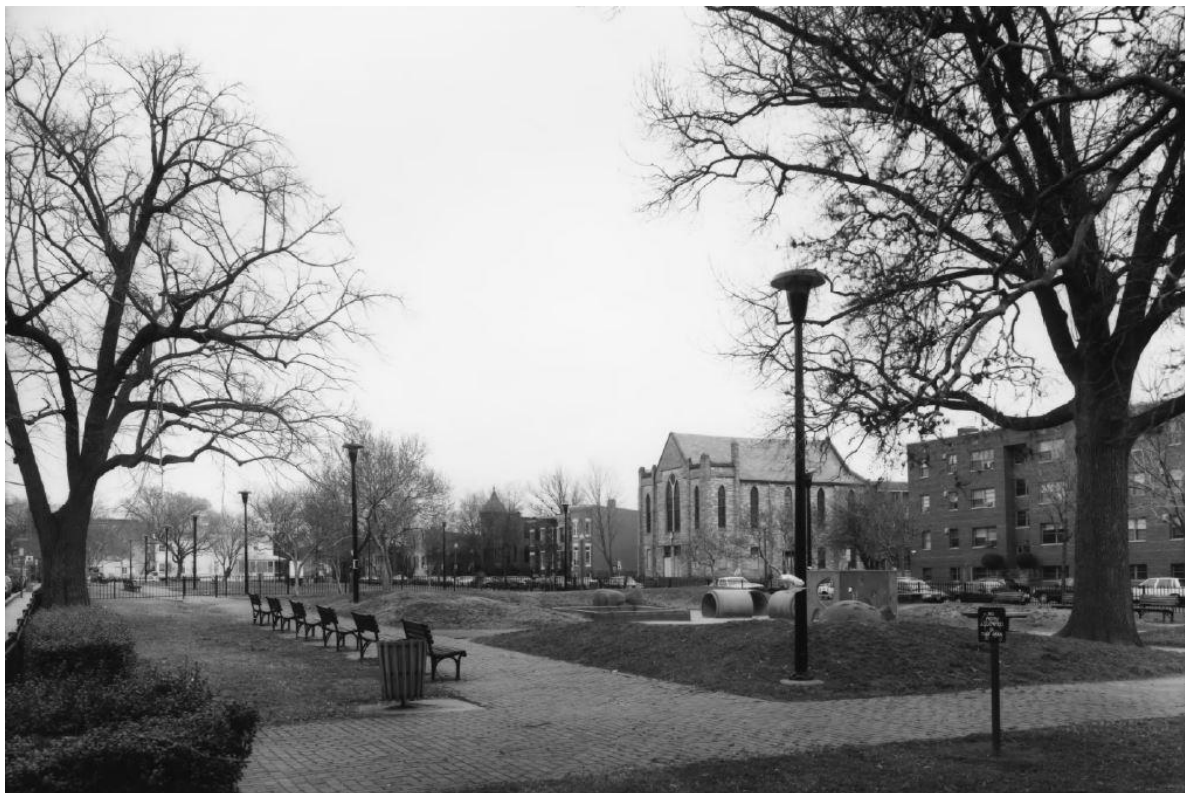
FIGURE 39: A 1992 HABS photograph of Marion Park shows the modern playground, mushroom lights, tulip trashcans, regulatory signage, and benches. The 1964 modern design of Marion Park remained largely intact. (McWilliams, 1992)

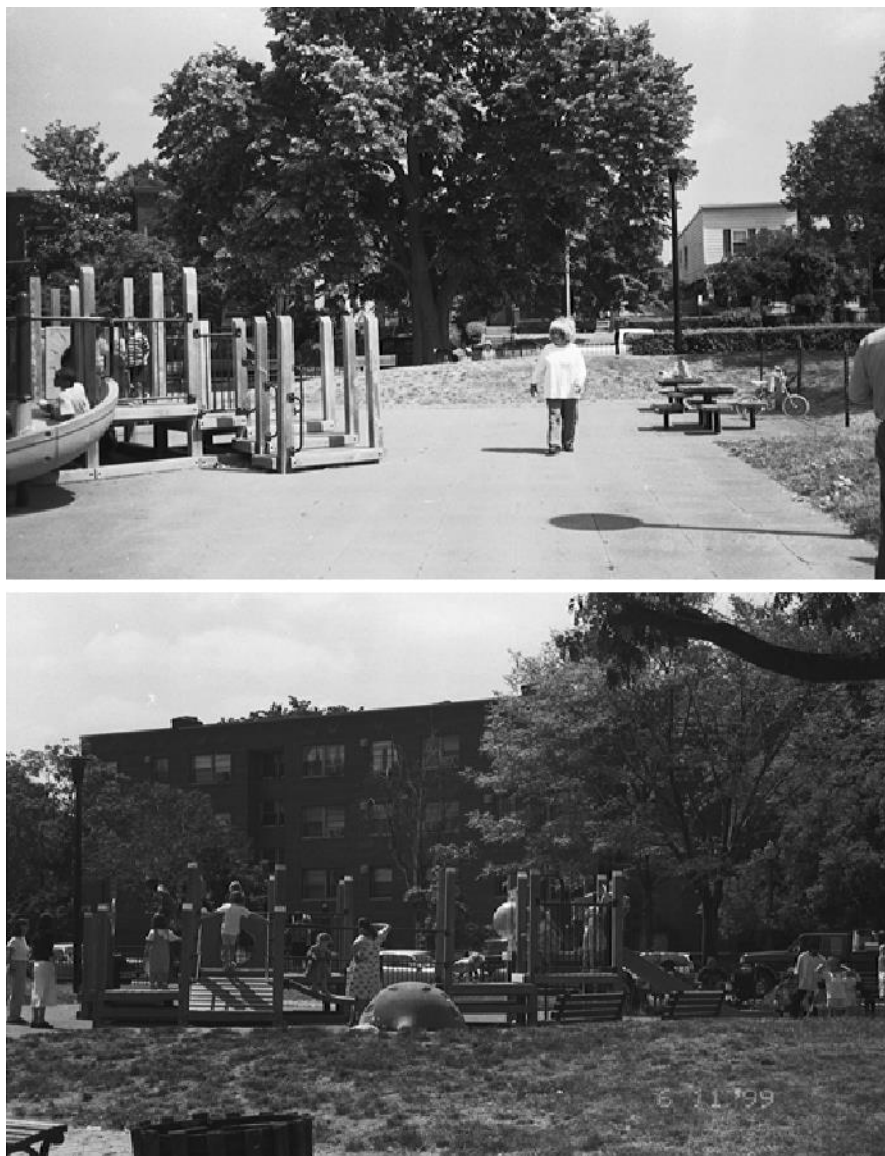
FIGURE 40: A 1999 survey of Marion Park shows the new wooden playground, kiddie tables, and rubber play mat. The berms surrounding the playground were retained as part of the new design, as was the turtle, benches, and tulip trash cans. (“[Marion Park] NACE Site Survey,” furniture file, NACE)

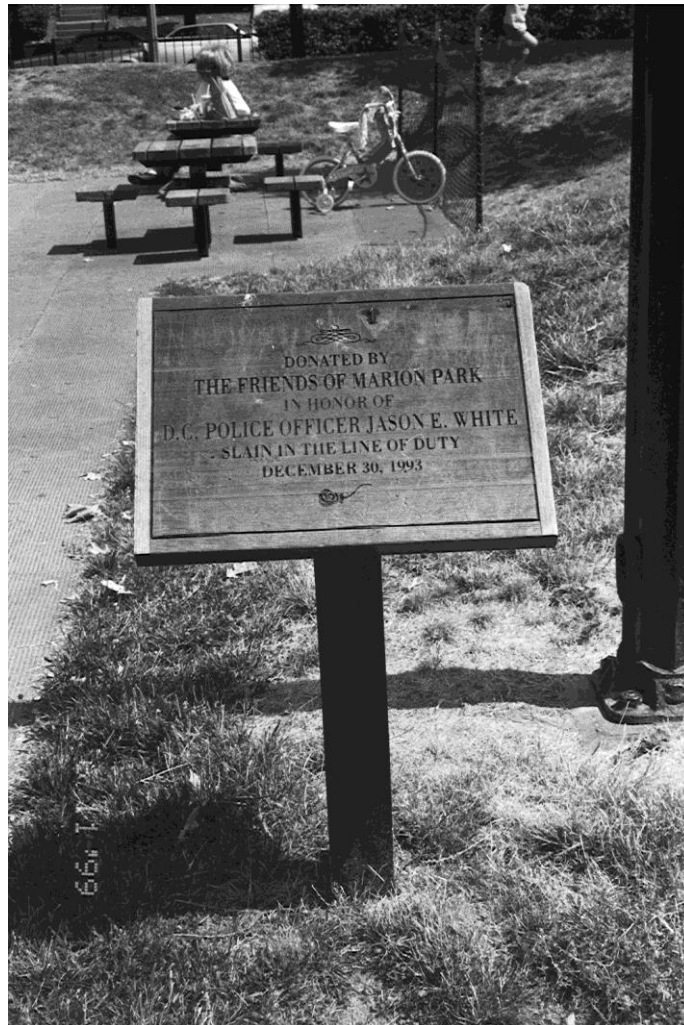
FIGURE 41: Commemorative plaque to Officer Jason E White located in the southeast corner of the playground looking north in panel A2. The plaque has been since removed for unknown reasons. (“[Marion Park] NACE Site Survey,” 1999, furniture file, NACE)

In 1995, after the final period of significance, the park’s commemorative use was expanded, as the playground was dedicated in honor of slain police officer Jason E. White of the nearby police precinct. A memorial plaque was installed to honor Officer White’s memory in the southeast corner of the playground. At the same time, a small tree was planted near the playground to honor another neighborhood officer, Raymond L. Hawkins, who died in the line of duty. Both the tree and plaque were removed sometime after their installation in 1995 for unknown reasons. The park retains its commemorative use based on its association with Francis Marion, but there are no extant features associated with the memorials to Officer Jason E. White or Officer Raymond L. Hawkins (“Honoring a Slain Officer,” *The Washington Post*, January 13, 1994: DC 1; Hawkins et al., 1999; Reservation 018, Reservation Files, NCA).

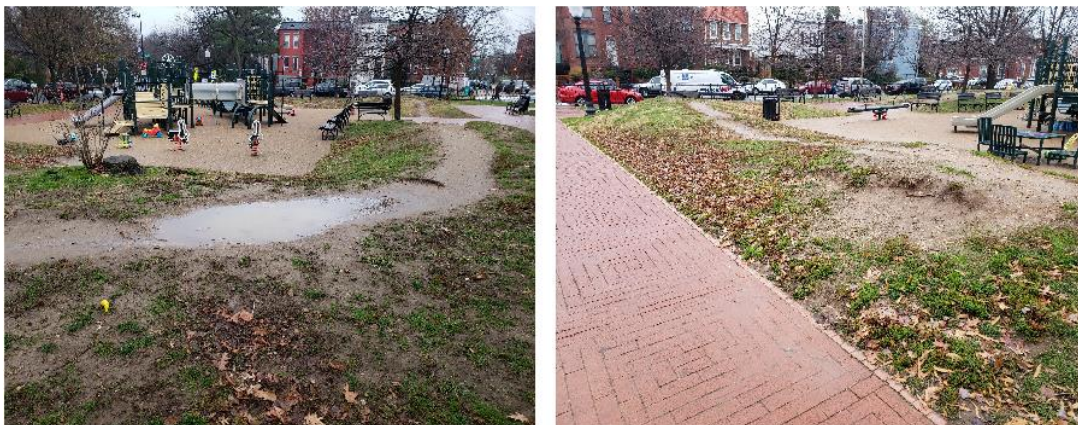
FIGURE 43: Views to the northeast (left) and southwest (right) of the earthen berms surrounding the Marion Park playground. (Molly Lester, 2019)

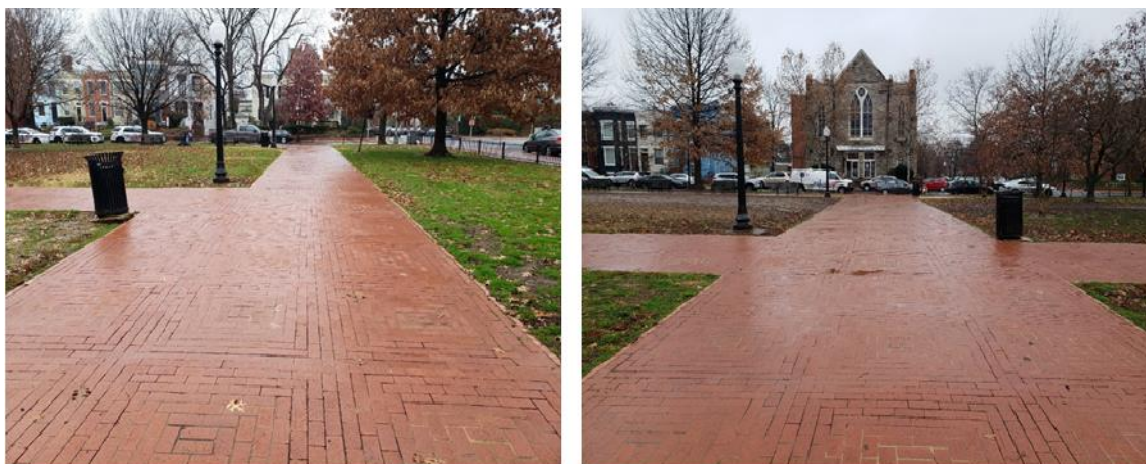
FIGURE 44: Typical circulation conditions in the Marion Park cultural landscape include the 5'x5' square brick modules used to pave the east-west and north-south walkways. (top) View to the south; (bottom) view to the north. (Molly Lester, 2019)

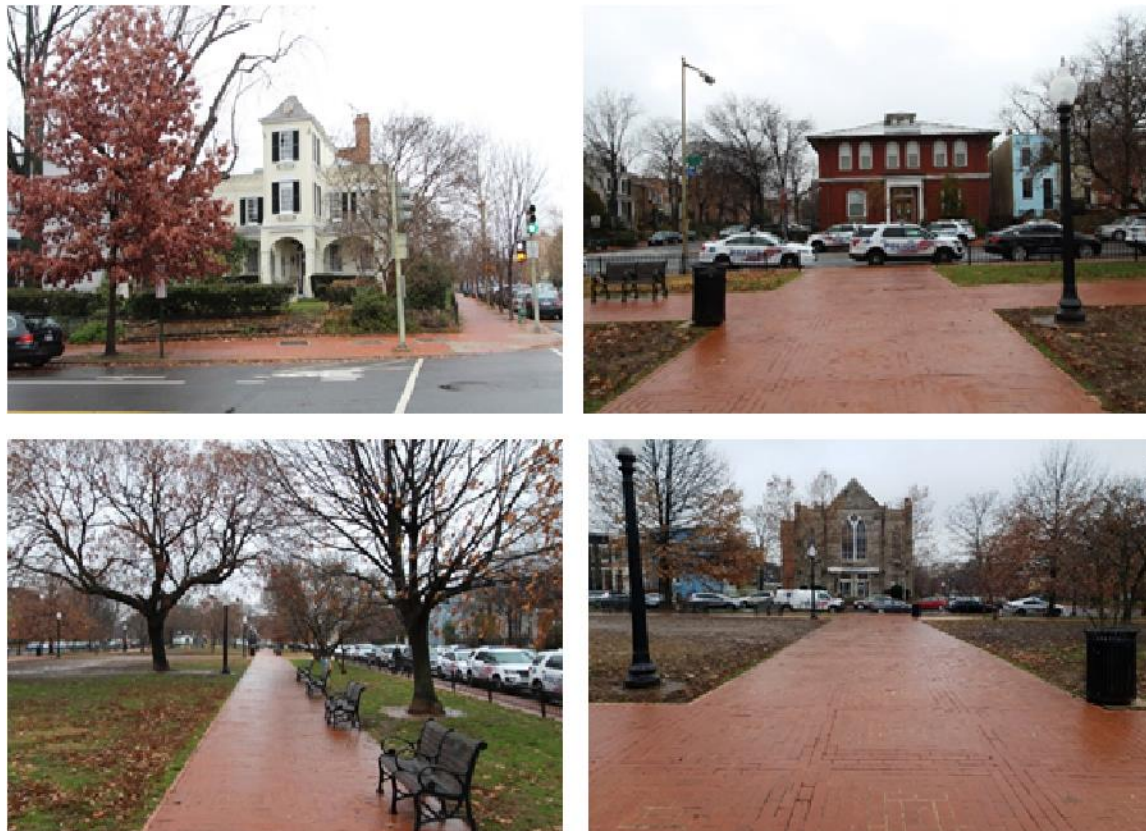
FIGURE 45: (1) View to the north of the historic Carbery House from the intersection of 6th Street SE and South Carolina Avenue SE; (2) Axial view of the historic 5th Street Police Precinct to the north; (3) View to the west of internal vistas along walkways in the cultural landscape; (4) View of the historic Mt. Jezreel Baptist Church to the south. (Photos by CLI author, 2019)

The internal vistas that were embedded in the 1964 design remain largely intact, retaining the same focal points as the historic views that existed during the period of significance. The unobstructed views through the full

extent of the park remain intact. The walkways, fences, and perimeter vegetation continue to reinforce the interior sightlines of the park, consistent with conditions during the final period of significance.

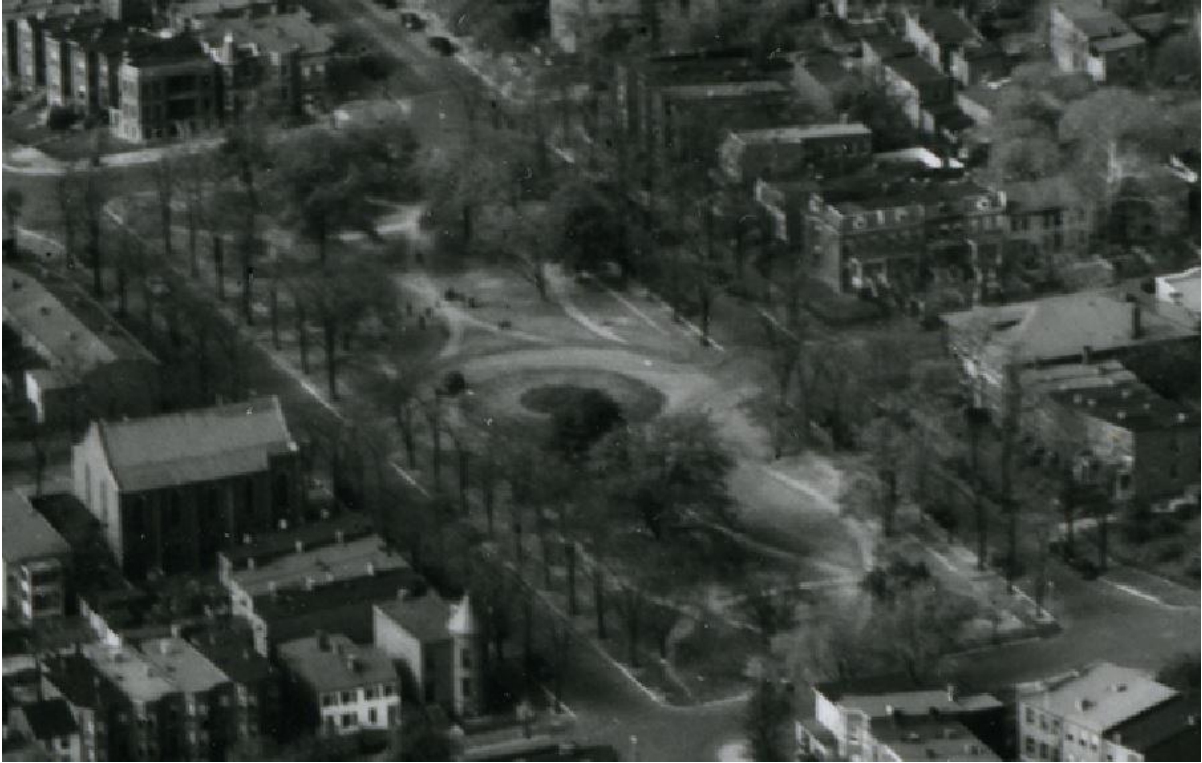
FIGURE 47: 1938 aerial photo of Marion Park, view to the northwest. Note the replacement of the fountain with a planting bed and the openness of the central part of the park. Vegetation by this time was mostly limited to the edges of the park. (AS 235, Aero Services Photograph Collection, Kiplinger Library)

Conditions in Marion Park had greatly deteriorated by the third period of significance (1925-1933). By the late 1930s, much of the vegetation in the park had died and been removed but not replaced. This left large open lawns in place of planting beds, and visitors increasingly used the lawns for active and passive recreation. This necessitated the constant reseeding of the park's grassy areas. By 1938, the vegetation pattern in Marion Park emphasized open lawns and planted edges. A 1938 aerial photograph shows this change in vegetation. Also by this time, the central fountain was replaced with a circular planting bed, as seen in the center of the photograph (AS 235, Aero Services Photograph Collection, Kiplinger Library).

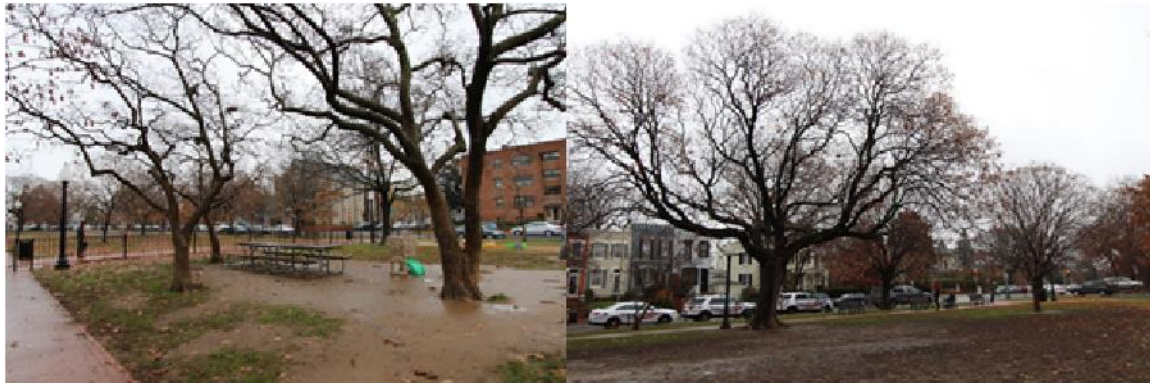
FIGURE 51: (left) These Star Magnolia trees, located in the western central panel of the cultural landscape date to the final period of significance (1962-1970) (Photo by CLI author, 2019); (right) These Panicked Goldenrain trees, located in the eastern central panel of the cultural landscape date to the final period of significance (1962-1970) (Photo by CLI author, 2019).

The grassy lawns are intact and consistent with the final period of significance. Most of the planting beds added after the last period of significance are no longer extant and were removed between 2004-2019.

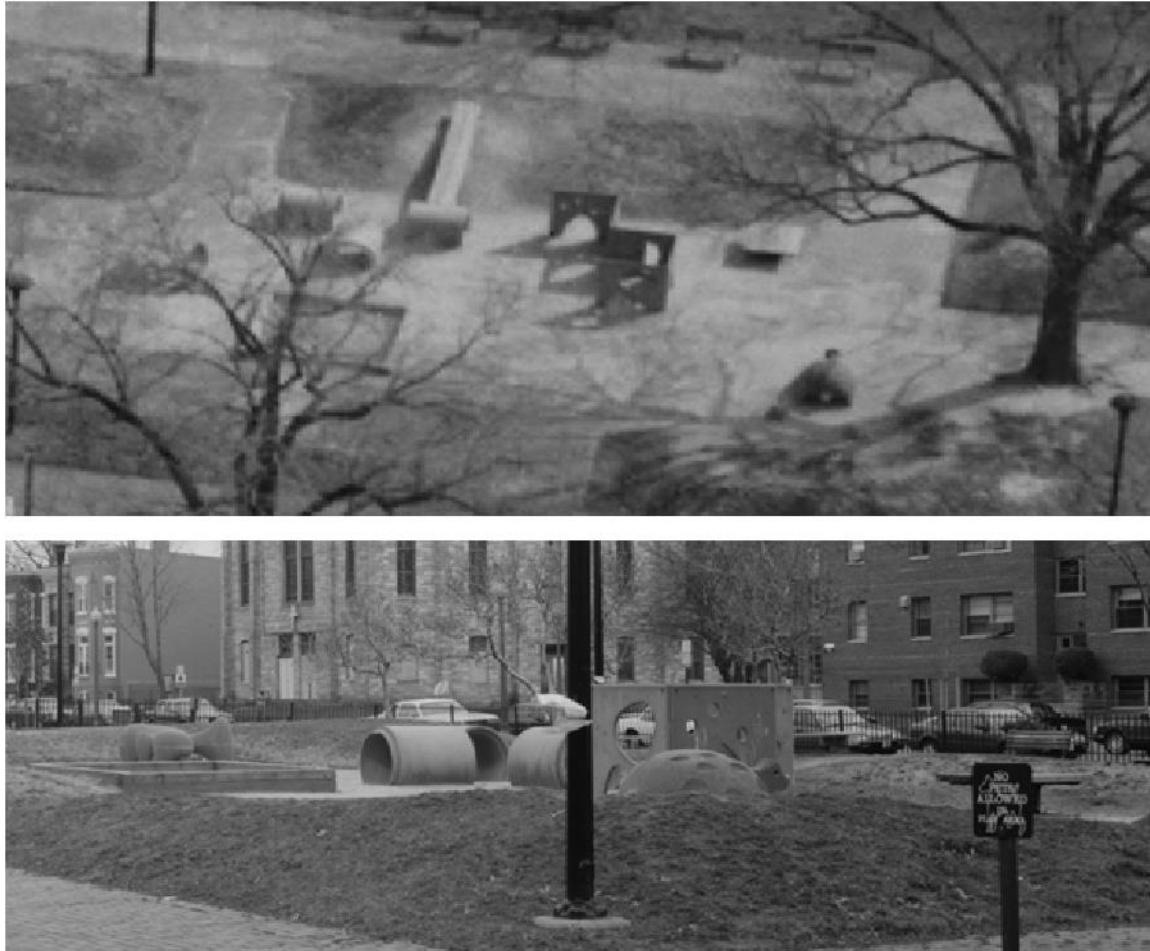
FIGURE 52: (top) Cropped aerial view of the Marion Park playground looking to the south, showing the sandbox, “fantasy walls,” sandbox, spring platform, concrete pipes, and turtle; (bottom) The Marion Park playground, installed in 1964, featured imaginative play equipment. Cropped view to the southeast. (Boucher HABS DC-679, 1992; McWilliams, HABS-DC679, 1992)

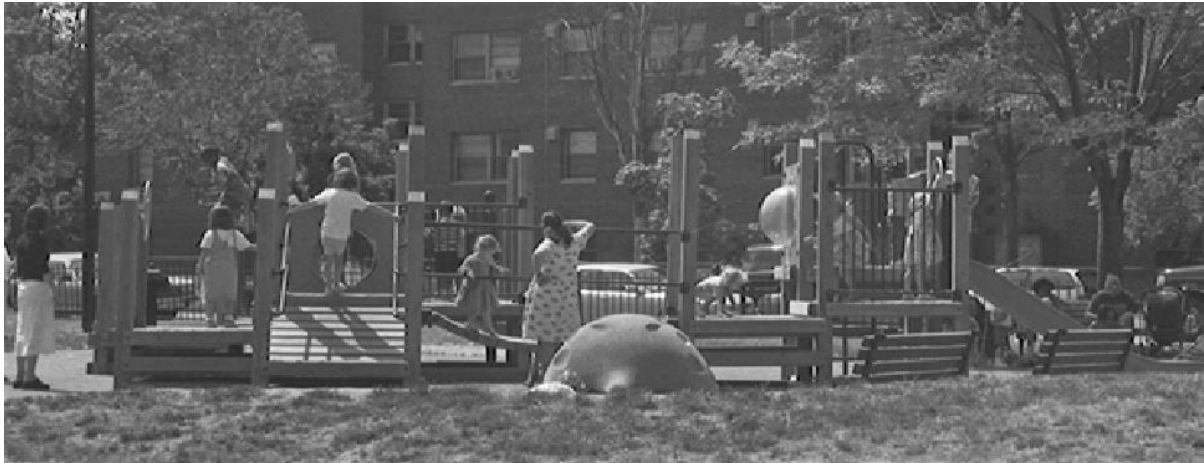
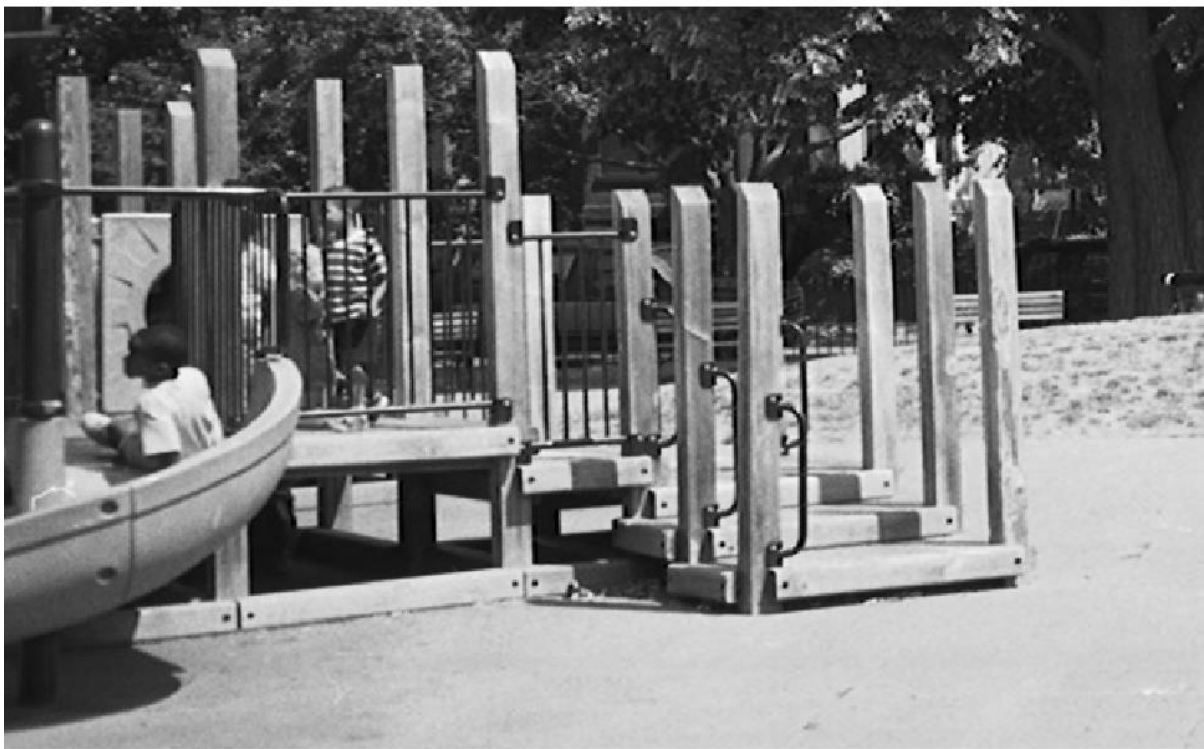
FIGURE 53: (top) In 1995, the Marion Park playground was replaced, retaining only the concrete turtle from the 1964 design. Cropped view to the south; (bottom) The 1995 playground structure featured plastic slides and metal safety equipment. Cropped view to the north. (“[Marion Park] NACE Site Survey” 1999, furniture file, NACE)

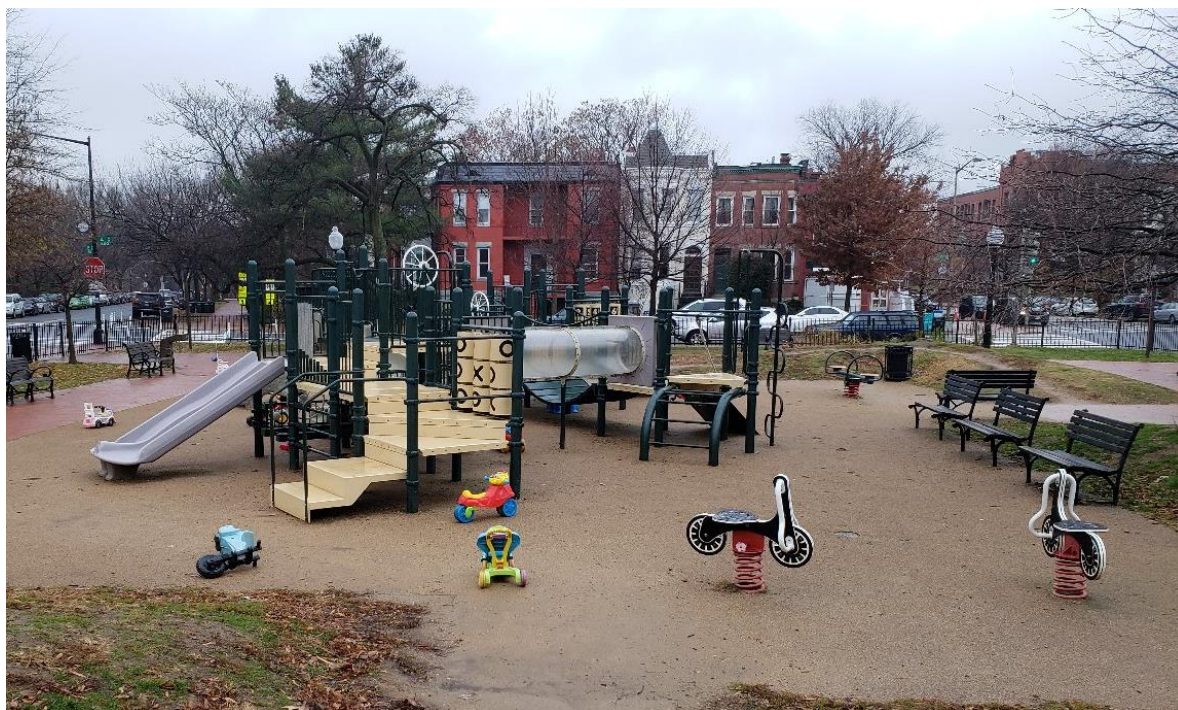
FIGURE 54: The extant Marion Park playground is located in the same location as the first playground dating to the 1962-1970 period of significance but is non-historic. (Photo by Molly Lester, 2019)

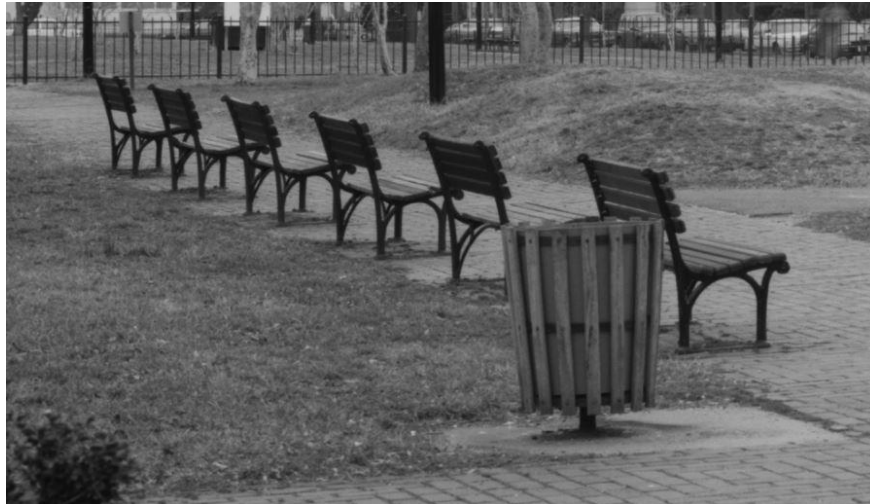
FIGURE 55: Standard NPS benches were installed by the NPS during the 1964 redesign of Marion Park. These benches were located in rows along the east-west walkways of the park. Cropped view to the southeast of the benches on the north side of the playground (McWilliams, HABS DC-679, 1992).

Designs for a playground rehabilitation in 2005 called for the addition of three benches on the western edge of the play area, increasing the number of benches in the play area to five ("Marion Park Playground Rehabilitation," 2005). Between 2009-2014, the majority of the benches installed in 1964 (during the fourth period of significance) were replaced with larger, newer models with three curved armrests (Google Streetview, 2009-2014).

Five benches date to the final period of significance (1964-1970). These 5 benches are located along the edges of the play area in panel A2. Each consists of a cast-iron frame with a curved wood-slat back and seats. The cast-iron frame features a small scroll and elegant cross-bracing in both the horizontal and vertical directions. Each bench is 3’ 10” long and approximately 34” tall. These 5 benches were moved into the play area sometime after the final period of significance, where there were historically no benches. All other benches were replaced circa 2014 with newer models that featured three curving armrests. These benches are similar in aesthetic and most are in the same locations as the 1964 design. Other changes to the 1964 bench plan include the removal of one bench from the cluster of benches along panel A1, a reduction of five from the six drawn in 1964. Two benches were added to walkway along panel A4, facing the playground, where there were never benches historically (“Park Improvement Plan,” 1964).

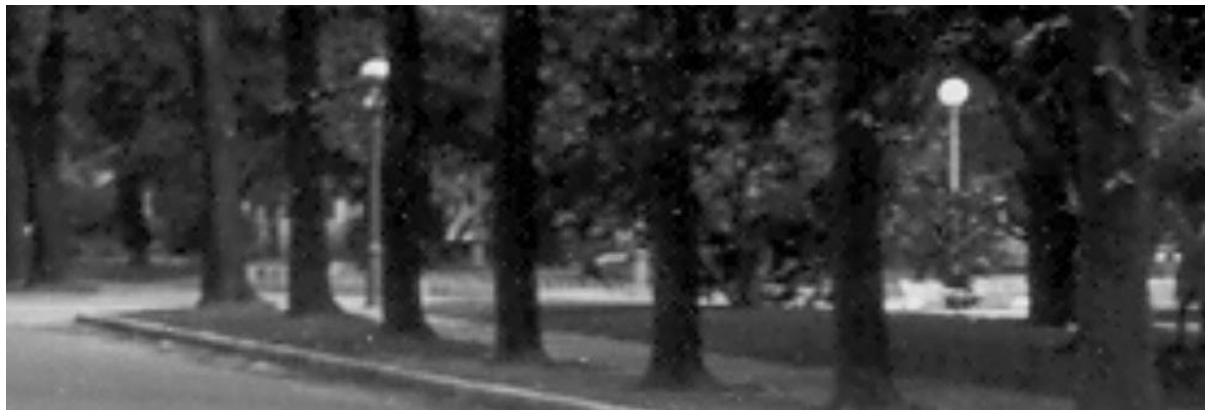
FIGURE 56: Close-up of the two types of lighting in Marion Park by 1927 along 5th Street SE. The light on the left was likely gas powered, and the spherical globe-light on the right was likely one of two electric lights installed in the cultural landscape by this time. Cropped view to the northwest (Reservation 18, Reservation Files, NCA, 1927).

Eight gas lamps were added to Marion Park in 1885, during the second period of significance (1884-1905); their locations were not specified in the reports (1885 OPBG Annual Report). These lights were not described in the report and nothing is known about their appearance. However, a 1927 photo shows two types of lights in Marion Park (Figure 56). One light shown is a tapering, fluted pole with a capital and globe on top; these were likely the gas lamps described in the 1885 OPBG annual report. The eight lamps were not lit until 1893, when they were provided with burners for the first time (1893 OPBG Annual Report). The lampposts were painted annually under the tenure of the OPBG. By the time Marion Park was inventoried in 1925, two of the eight gas lamps had been converted to electric. It is unknown what these lights looked like or where they were placed. However, a 1927 photograph shows a simple light with a narrow-fluted column and a plain globe at its top (see Figure 56). In 1929, the Office of Public Buildings and Public Parks authorized the Washington Gas Light Company to remove the remaining six gas lamps. It is unknown if additional electric lights were added in their place (Reservation 018, Reservation Files, NCA).

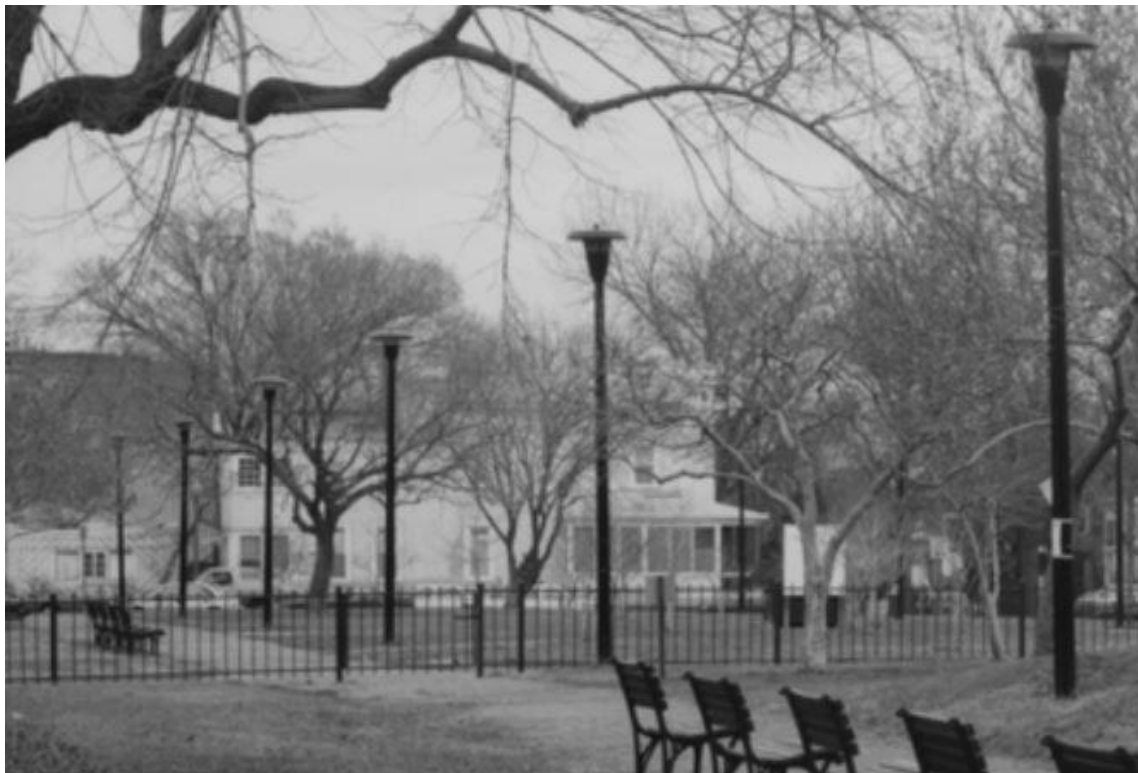
FIGURE 57: Fourteen mushroom-style lights were installed in Marion Park in 1970, during the final period of significance (1962-1970). The lights were evenly spaced along the east-west walkways. Cropped view to the southeast of the benches on the north side of the playground. (McWilliams, HABS DC-679, 1992)

It is unknown if any changes were made to lighting in the cultural landscape between 1929 and 1970. In 1970, during the final period of significance, all existing lighting was removed and replaced with 14 mushroom-style lights using funding from the Beautification program. These lights consisted of a simple column with an urn shaped luminaire, topped with a flat plate that resembled the cap of a mushroom. The mushroom-style lights were placed at regular intervals along the east-west walkways of the cultural landscape (“Lighting Plan,” 1970; Reservation 018, Reservation Files, NCA).

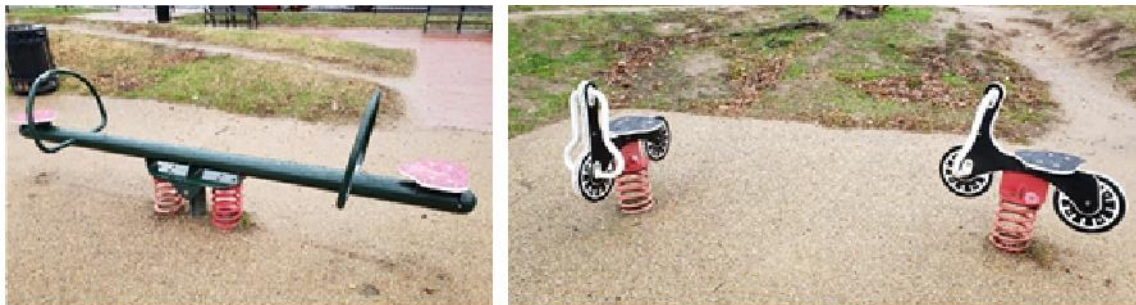
FIGURE 59: A seesaw and 3 spring-mounted child's play motorcycles were installed between 2005-2007 in the Marion Park playground area. (Molly Lester, 2019)

When the playground was redesigned between 2005-2007, the National Park Service added three spring-mounted child's play motorcycles and a seesaw to the east end of the cultural landscape. No further changes have made to the small-scale features in the play area since 2007.
