Marion Park

National Capital Parks - East

Cultural Landscapes Inventory
National Park Service

Urban Heritage Project | PennPraxis
University of Pennsylvania
June 2020

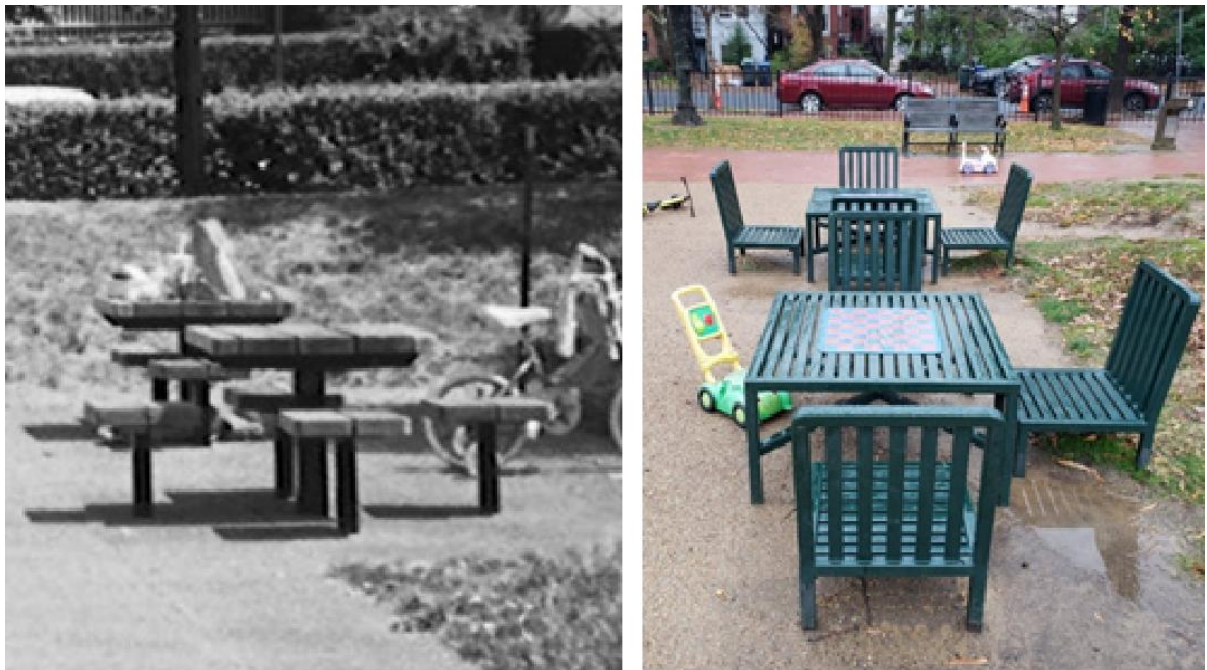
FIGURE 60: “Kiddie tables” were added in the 1995 playground area redesign (left) and were replaced sometime between 2007-2014 with newer metal versions (right). (Excerpt from “[Marion Park] NACE Site Survey, furniture file, NACE, 1999; Molly Lester, 2019)

Two “kiddie tables” were installed for the first time in 1995, during the playground remodel on the east end of the cultural landscape. These tables consisted of square wooden plank seats and table tops set on steel center posts. They were designed to be diminutive in size to encourage use by children (“[Marion Park] NACE Site Survey,” 1999). These were replaced with newer metal tables between 2007-2014, when the cultural landscape underwent a series of rehabilitations (Google Streetview, 2007-2014). The new kiddie tables were approximately 2’ tall and consisted of metal tube framing with metal horizontal slats for a tabletop. Each table was surrounded with two chairs of a similar design, with metal backs. The table to the north had four chairs and the table to the south had two.

The current kiddie tables replaced 2 others that were built in 1995. They consist of green-painted metal tubing welded-together with metal horizontal slats for a tabletop. Each kiddie table is approximately 2’ tall and is surrounded with chairs of a similar design, with metal backs. The table to the north had four chairs and the table to the south had two. (“Marion Park Playground Rehabilitation,” 2005). One table has 4 chairs and the other has 3 in order to accommodate a wheelchair.

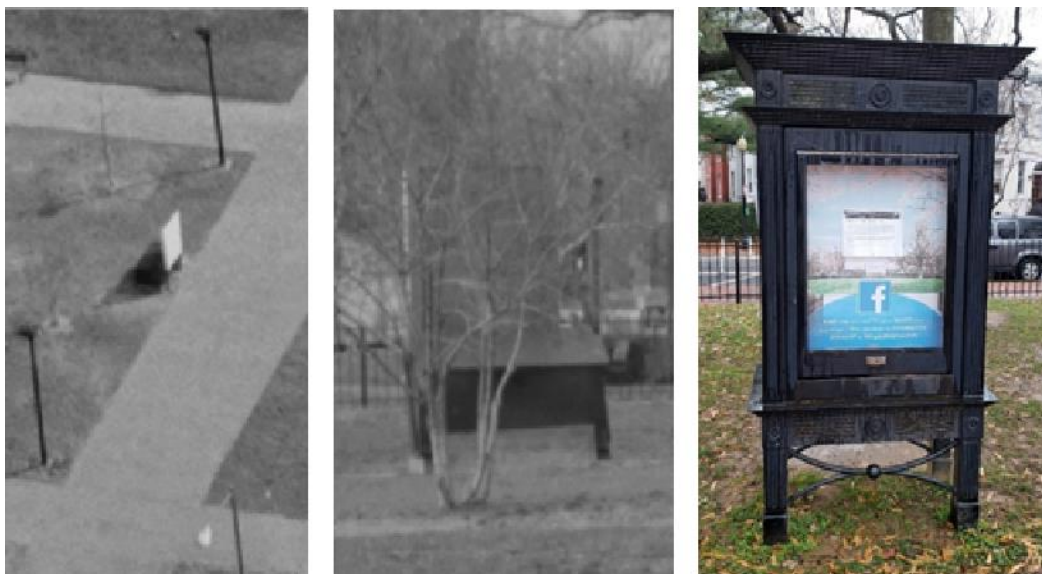
FIGURE 61: A large bulletin board was extant when HABS photographed Marion Park in 1992. It was located along the walkway between panels B2 and C2. It appears to have been constructed of wood, with a roof storage box at the back. (left) View to the southeast; (center) view to the northwest showing the back side of the bulletin board; (right) View to the west of the current community kiosk/bulletin board in Marion Park, installed after 1995 and extant by 2005-2007. (Excerpt from Boucher, HABS DC-679, 1992; Excerpt from McWilliams, HABS DC-679, 1992; Molly Lester, 2019)

In 1995, plans put forth by the Friends of Marion Park and the National Park Service called for the installation of a new community bulletin board in conjunction with the redesigned playground. This is likely the bulletin board pictured below (Figure 61 left and center) (Reservation 018, Reservation Files, NCA). Between 2005-2007, a new ornate metal and glass kiosk replaced the previous bulletin board; it was placed in the southeast corner of Marion Park (Google Street View, 2007).

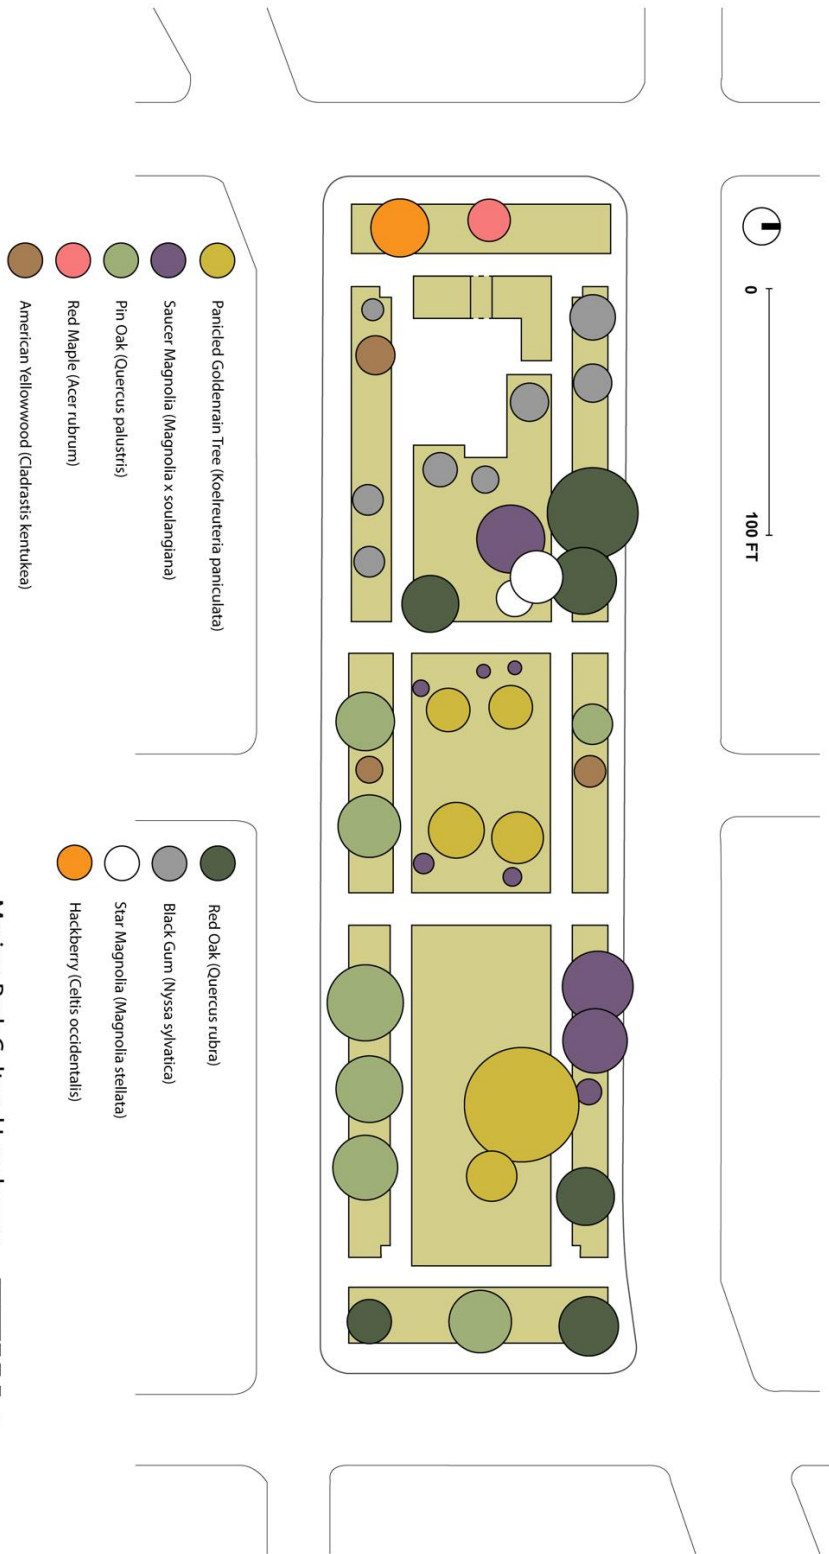
Marion Park Cultural Landscape
Existing Vegetation
2020

Count	Common Name	Scientific Name	Dimensions
1	October Red Glory Maple	<i>Acer rubrum</i> 'October Glory'	2-2.5" diameter
2,495	Stella de Oro Daylily	<i>Hemerocallis</i> 'Stella de Oro'	
110	Red Sprite Winterberry	<i>Ilex verticillate</i> 'Red Sprite'	
3	Panicled Goldenrain Tree	<i>Koelreuteria paniculata</i>	2-2.5" in diameter
1,750	Big Blue Liriope	<i>Liriope muscari</i> 'Big Blue'	
7	Saucer Magnolia	<i>Magnolia x soulangiana</i>	6-8' in height
3,200	Stainless Daffodils	<i>Narcissus</i> 'Stainless'	
6,450	Salome Daffodil	<i>Narcissus</i> 'Salome'	
8	Black Gum	<i>Nyssa sylvatica</i>	2-2.5" in diameter
106	Otto Luyken Cherrylaurel	<i>Prunus laurocerasus</i> 'Otto Luyken'	24" tall
1	Red Oak	<i>Quercus borealis</i>	2-2.5" diameter
2	Pin Oak	<i>Quercus plaustris</i>	2-2.5" diameter
